# Using Compost to Improve Water Quality

David Crohn  
University of California, Riverside

## Composting BMPs for Water Quality

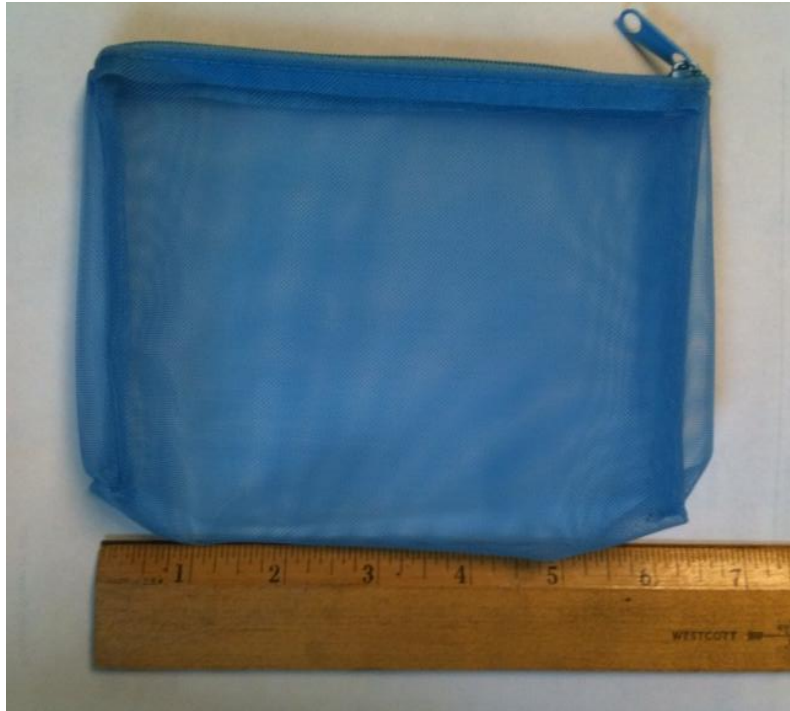
# 1. Water Holding Capacity

Difference between  
compost moisture  
at “field capacity”  
and the compost  
moisture in the pile.

$$\text{Wet basis moisture content} = \frac{\text{Bag mass with moist compost (g)} - \text{Bag mass with dry compost (g)}}{\text{Bag mass with moist compost (g)} - \text{Empty bag mass (g)}}$$

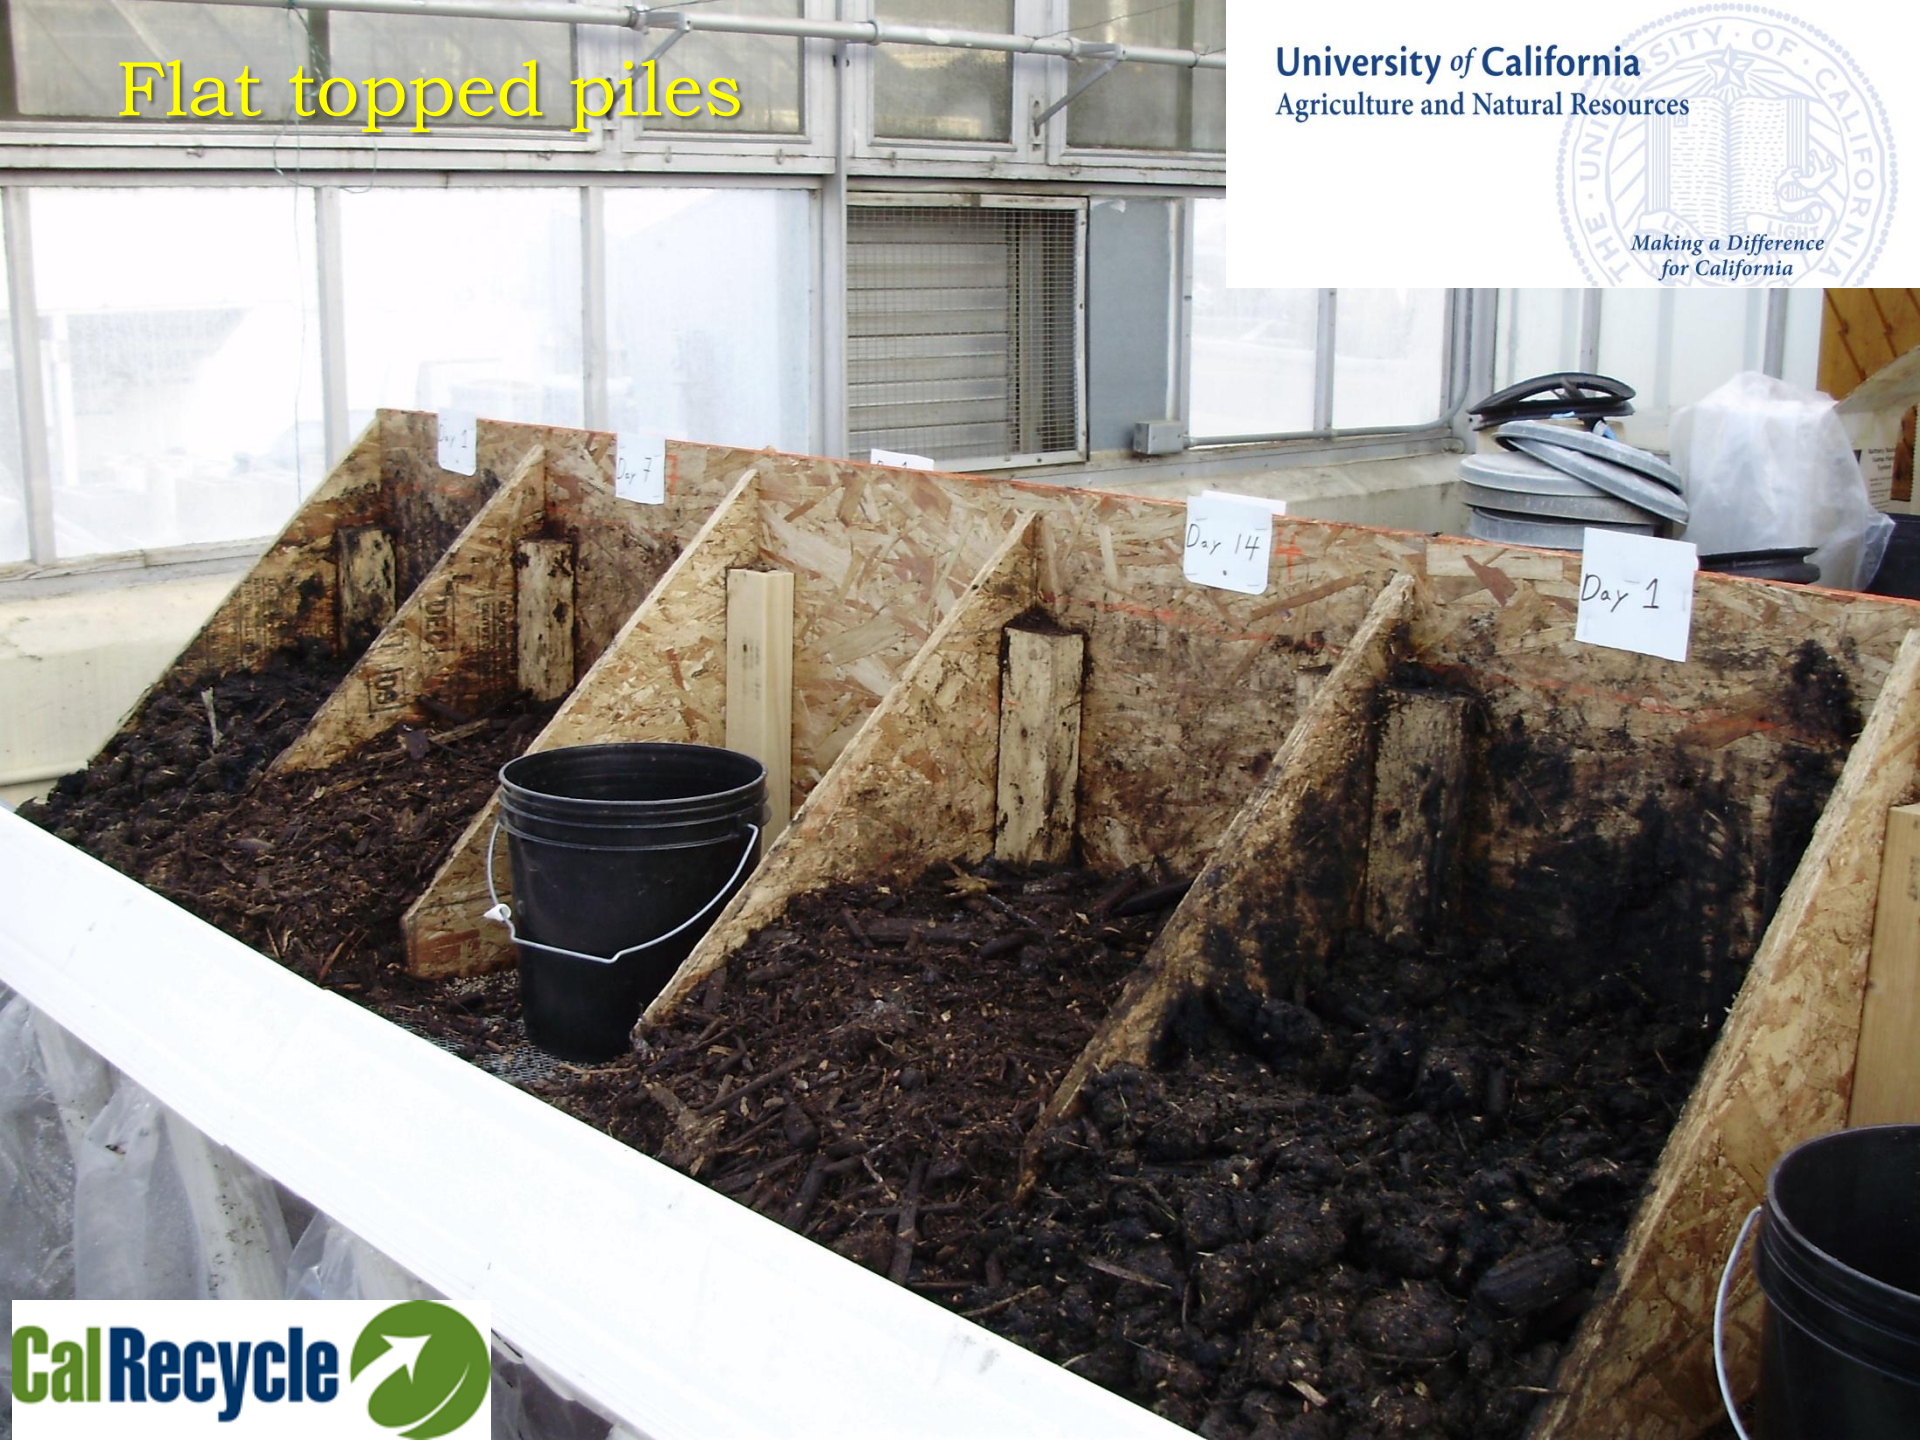
# Flat topped piles

- ▶ fresh material installed to approximately 17 cm
- ▶ covered with 1 cm oven dry compost
- ▶ flat area extended to natural angle of repose
